UNIVERSITY OF BIRMINGHAM

MA in Historic Environment Conservation

Medina House and former Turkish Baths Conservation Management Plan

March 2010

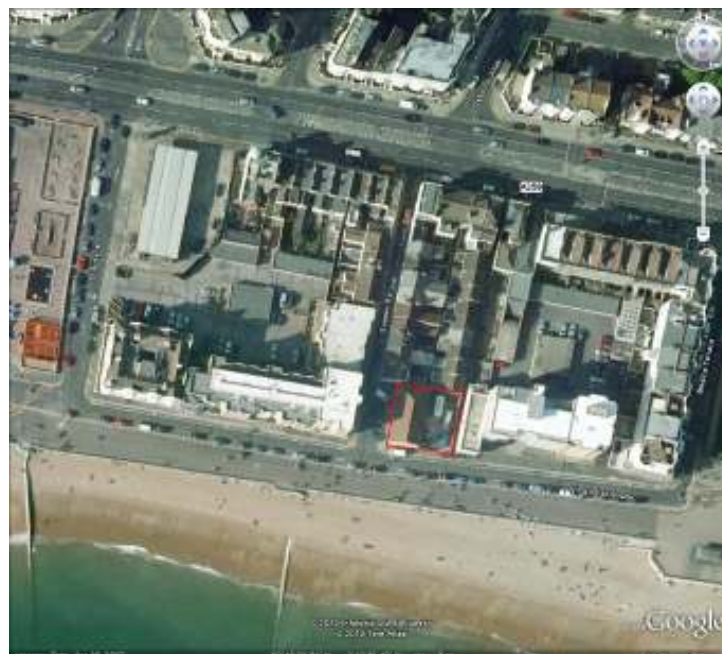
As highlighted on the aerial view in Figure 3 the site incorporates one building, Medina House, and the adjacent land to the east.

Figure 3 Site boundary of Medina House and site of Former Turkish Baths

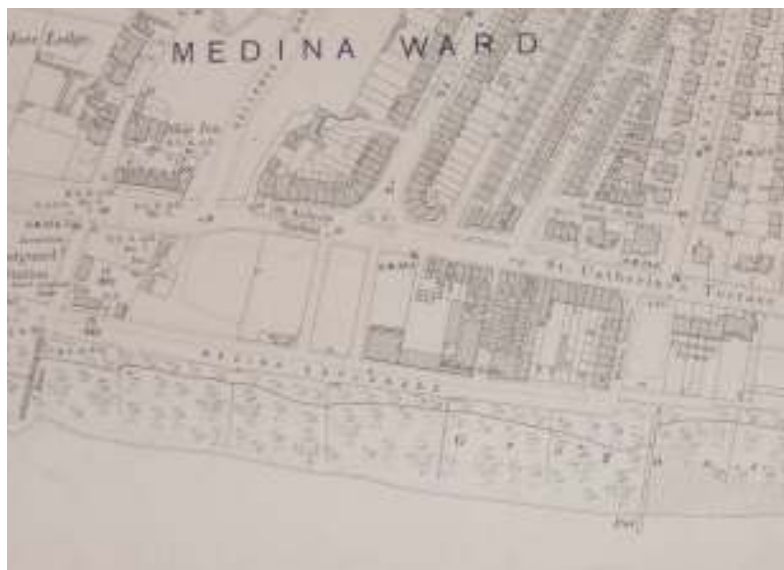
Figure 4 Map of Hove and Medina Baths in 1911 (Brighton History Centre)

Medina House was part of a larger site, Medina Baths, designed by architect PB Chambers, built by Hove Bath and Laundry Company in 1893-4. The whole site can be seen in a map from 1911, Figure 6, and in a later photograph Figure 7. The Bath House was bought by the council in 1918, by which time it was known as Hove Baths.

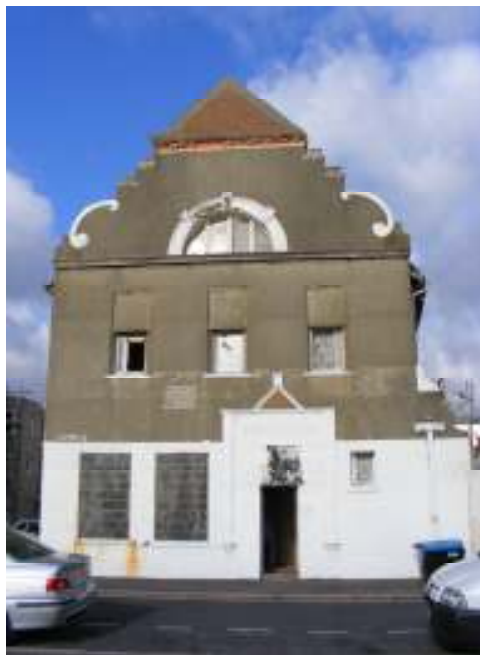
Figure 6 Medina House south elevation (author)

Medina House is a two storey building 10 x 20m with rendered brick walls. The south (front) elevation has a crow stepped Dutch gable with a cornice at eaves level, see Figure 6. The roof is steeply pitched, gabled to the front and hipped to the rear with open, projecting eaves. It is supported on wooden rafters with clay single Roman tiles. (Martin 2010).

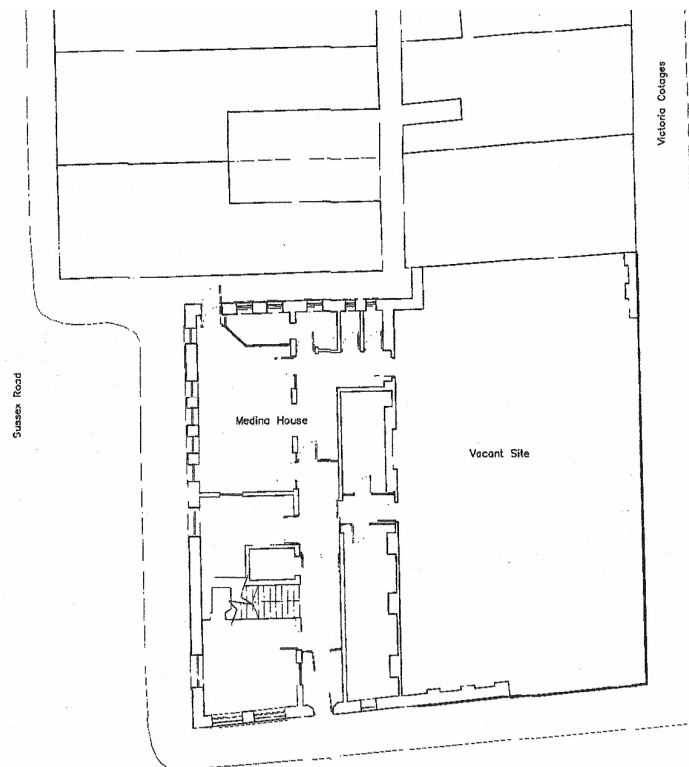
Figure 7 Ground floor existing layout (BHCC)

The original layout of Medina House is not entirely understood as the internal fabric has been much altered although some original features remain. The ground floor is difficult to make sense of as it is divided into many inter connecting rooms. The first floor would originally have been a large open space all the way up to the ceiling which is elaborately decorated and panelled. Some tiling is exposed in this large room but the walls are mostly clad. Five rooms in the north end of the building are contemporary with the

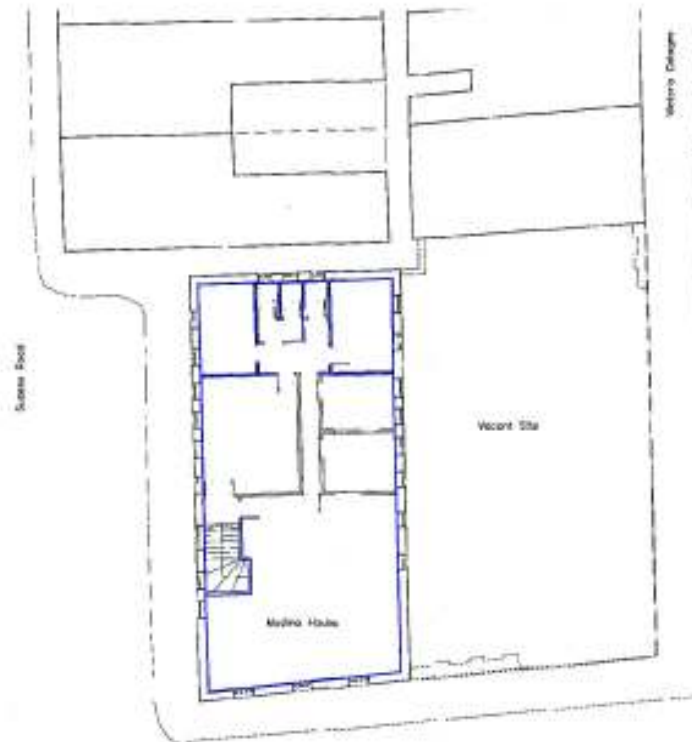
Figure 8 1st floor layout. Assumed original layout marked in blue (BHCC)

stairs in the heart of the building and it is concluded must be original. There is evidence of one slipper bath in one of these first floor rooms. The first floor has, at a later date, been further divided to create a second floor and divided into several rooms.

The supposed original layout of the first floor is marked on the plan in Figure 7 below.

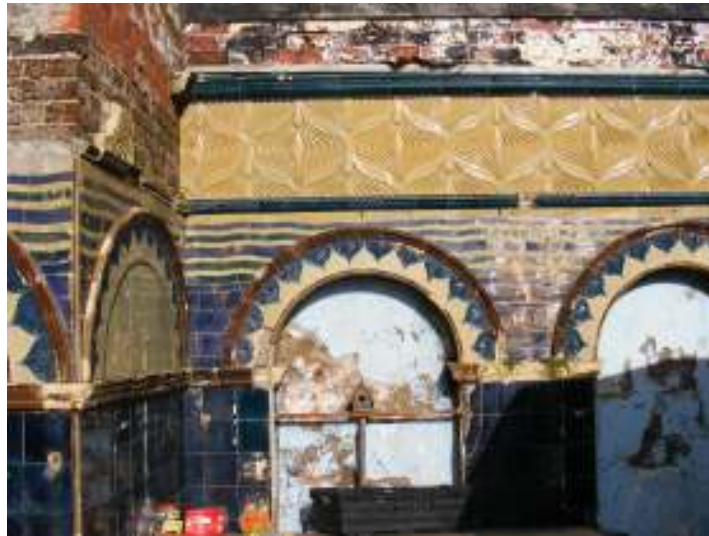
Figure 10 Baths site south elevation (author)

The site to the east measures 12 x 21m and the north and part of the east wall remain (R. Martin), see Figure 10. Despite common belief that this was the site of the Turkish Baths it was in fact the ladies bath. The majority of the building has been demolished, little evidence of its former use remains besides a considerable amount of floor to ceiling glazed ceramic tiles in a repeating pattern around all of the surviving walls.

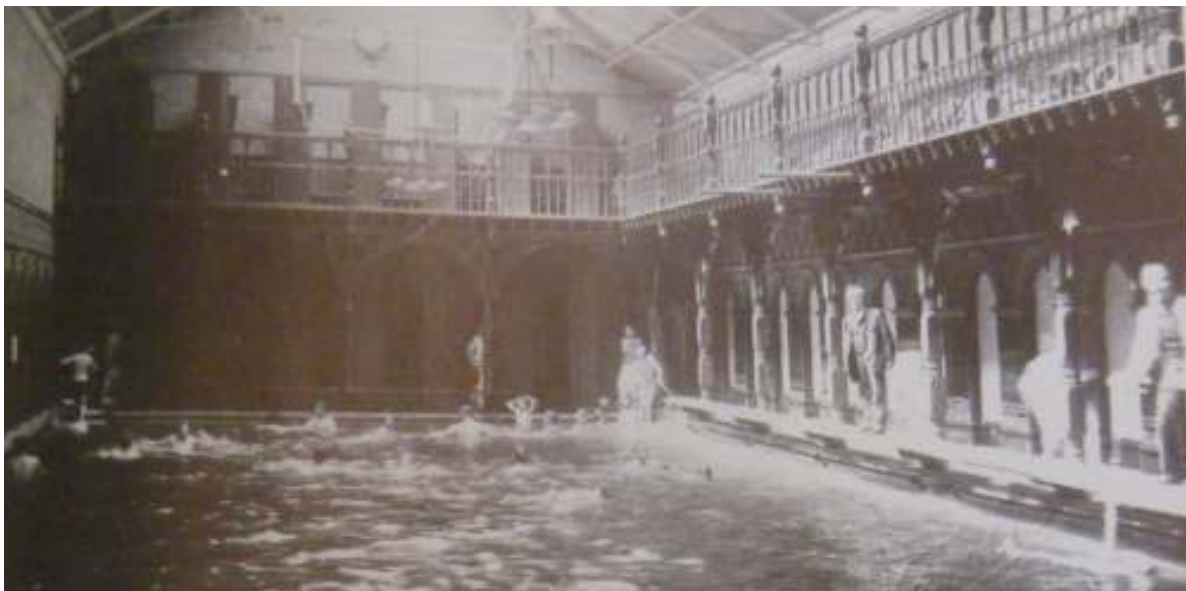
Figure 14 Medina Baths c. 1911 (Middleton 1996)

Medina Baths was designed by architect P.B Chambers and was an early example of a joint initiative of private and public investment. (Middleton 1979) It opened in September 1894 and consisted of two blocks: east and west. The west block contained the men's baths, Figure 14, a large swimming bath 93 feet 6 inches by 30 feet and 10 slipper baths. The east block contained the ladies baths: a smaller bath 65 feet by 33 feet and 6 1st class slipper baths. The sea water was filtered and maintained at a temperature of 70 F. (Middleton 1979)

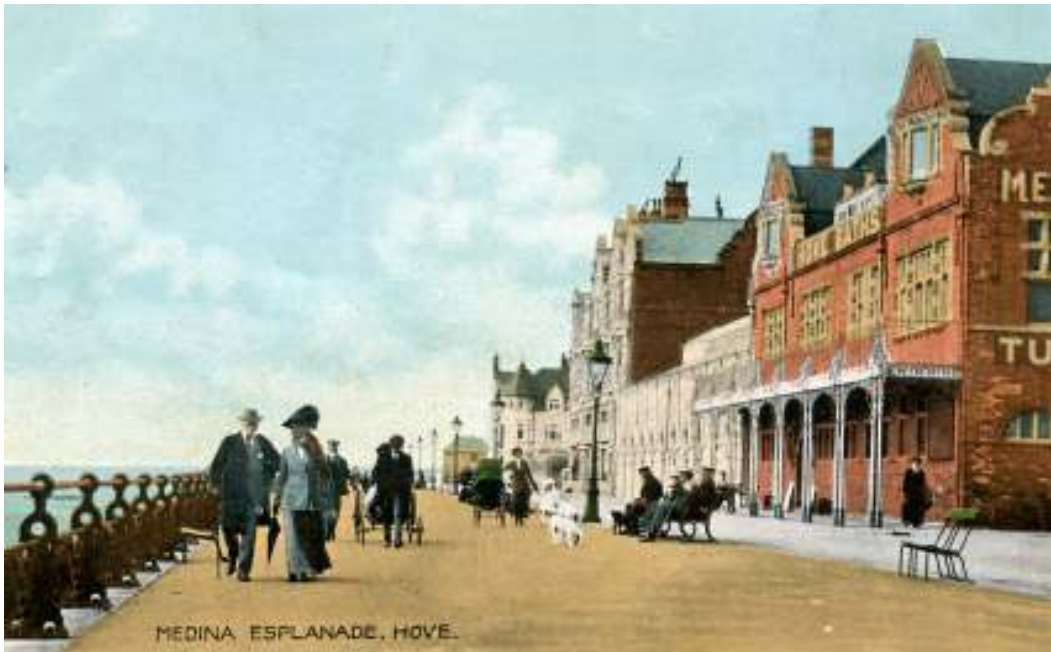
Fig 16 Medina Esplanade c. 1910 (www.regencysociety.org)

The architectural style of Medina Baths is typical of the Victorians' love of decoration and embellishment. The building was brick built with spectacular detailing in terracotta (Figure 16 & 17). It exemplifies an enjoyment of material and detailing such as externally cast iron balustrades, ornate balconies, carved rafters and the ornate overflow (Figure 18). Inside wooden panelling, stained glass and tiling is evident.

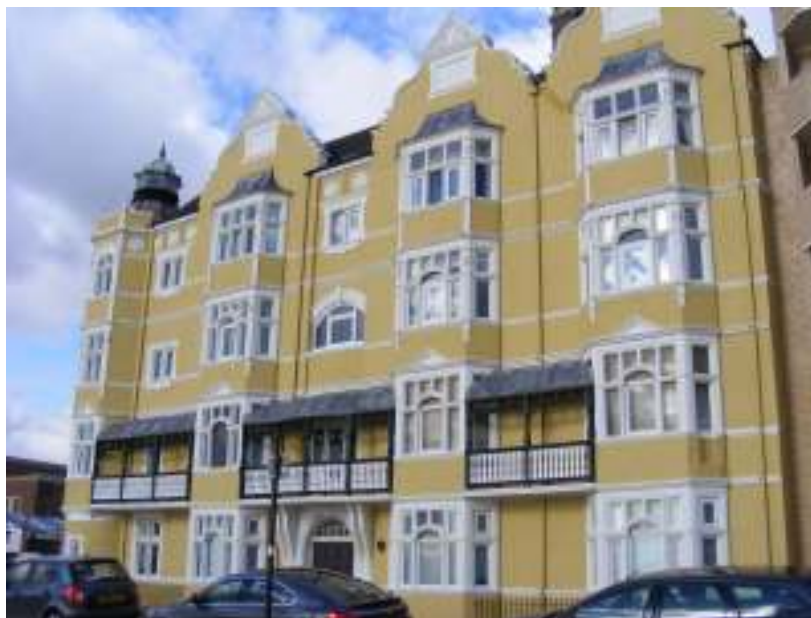
The distinctive crow stepped Dutch gable of Medina House, (there would originally have been 4 Dutch gables on the original, larger site) is visible on neighbouring buildings such as St Aubyns Mansions (Figure 19) and Medina Villas both Grade II listed.

Figure 19 St Aubyns Mansions, Kings Esplanade (author)

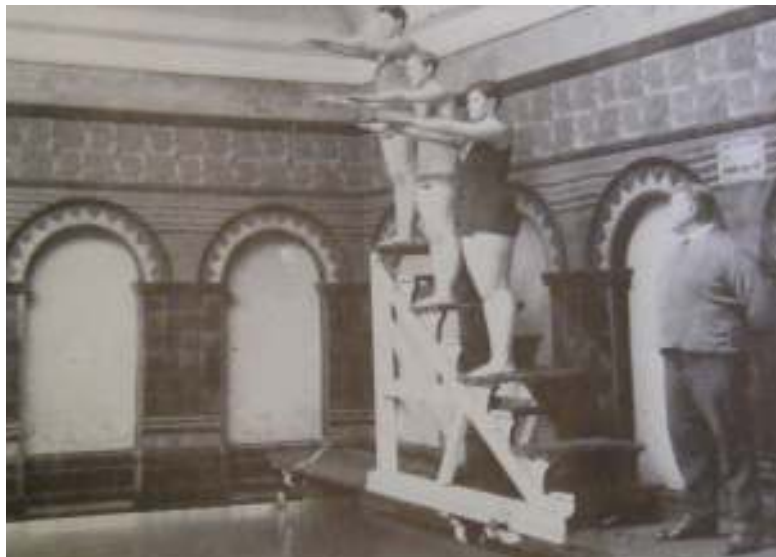
Figure 20 Medina Baths c. 1911 (Middleton 1996)

The ceramic scheme in the bath area achieves a high level of significance within the site. From photo documentation of the men's bath, Figure 20, we know this scheme would have run throughout the bath areas in the building.

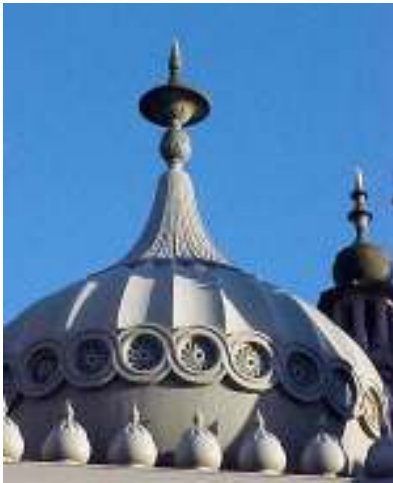
The Regency tones and seaside colours are used. The eastern stylisation of the Royal Pavilion is echoed in the ceramic scheme in the minaret form tiles as compared in Figure 21 & 22.

Figure 21 Royal Pavilion domes
(www.brighton-hove.gov.uk)

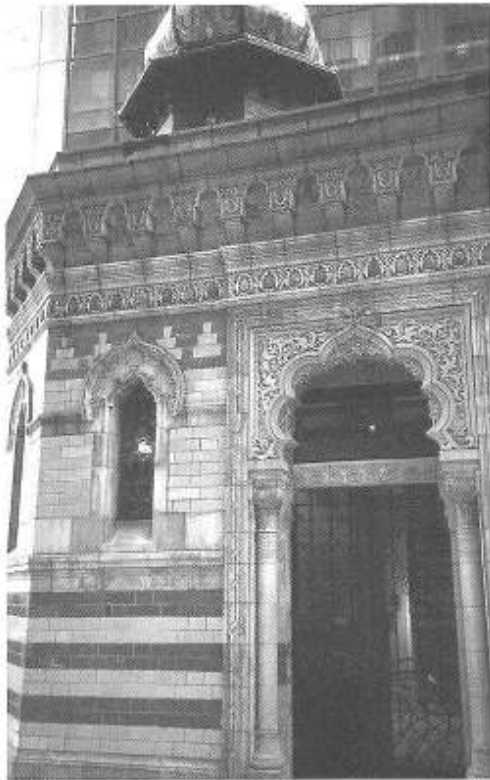
It is likely that this scheme was produced by Doulton or Craven Dunnill or a mixture of both. There were similarly styled interiors being commissioned around this time. The architect Harold Elphick designed the tiles for Nevill's New Broad Street Baths in London built in 1894, manufactured by Craven Dunnill, Figure 23, Craven Dunnill's extensive Islamic tile scheme of 1906 can be seen in the old stable block of Brighton Museum, Figure 24.

Figure 23 Neville's New Broad Street Turkish Baths, 1894 (Pearson 2005)

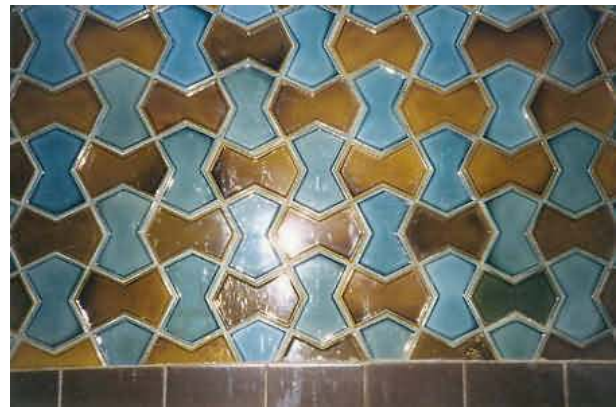
Figure 24 Islamic tiles in Brighton Museum, 1906 (www.victorianturkishbath.org)
